# Assessment of Shear Operation Tegular Unreinforced Beam and Reinforced Beam Under Monotonous Loads

EHSAN ELYASI\*<sup>1</sup> and ROXANA MONTAZERIAN<sup>2</sup>

<sup>1</sup>Department of Civil Engineering, Razi University, Kermanshah, Iran.

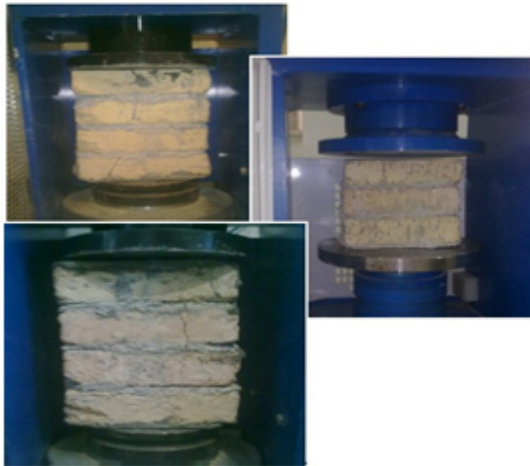
Fig. 1: A typical compression test

The compression test is performed on different compositions of mortar in accordance with the standards of ASTM<sup>4</sup> for masonry walls. To do so, the masonry components are built in quadruple and triple rows (see Figure 1). Then, the compression tests are performed on them, while the loading rate of samples is 5 mm per minute. The results are given in the following tables :

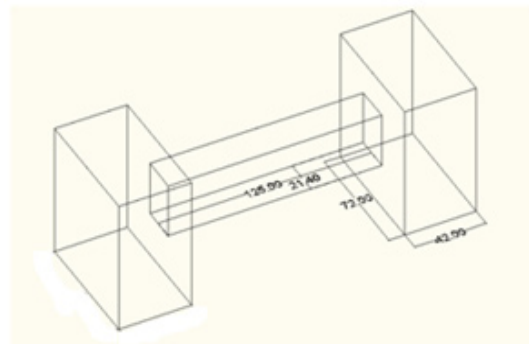
Fig. 2: The sample geometrical details

has the dimensions of 1250 \* 280 \* 214 mm (see Figure 2), while its bottom distance from the ground is 250 mm with beam height of 280 mm. The mortar composition is shown in Table 2. The brick beam is mounted on two stands of the same material, each with dimensions of 420 \* 720 \* 750 mm (see Figure 3.1).

The sample reinforced brick beam has the same dimensions (see Figure 2), while its bottom distance from the ground is 22cm with beam height of 30cm. The beam is reinforced by two #10 deformed bars for each section, in three heights of 8, 16.5, and 23 cm. The deformed bars are placed a line with beam length, as well as each stand (see Figure 3.2)

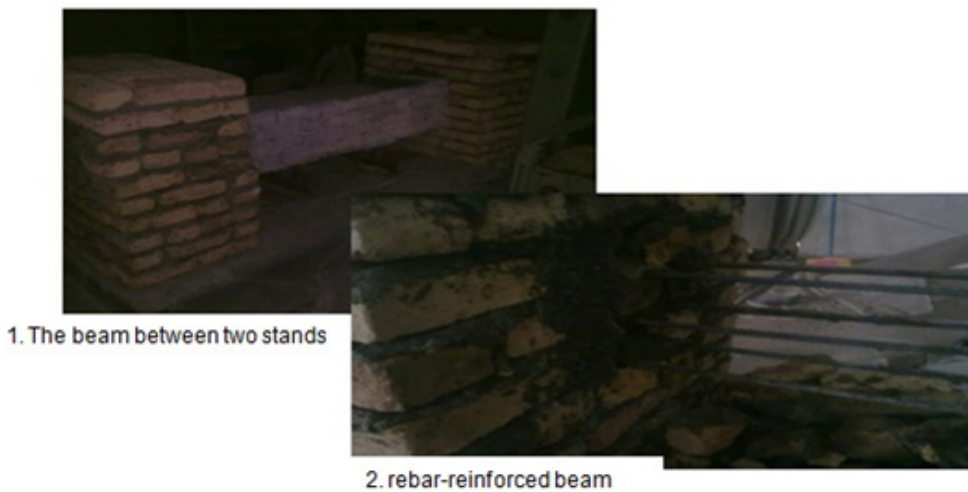
1. The beam between two stands

2. rebar-reinforced beam

Fig. 3: (1) The beam between two stands; (2) Rebar-reinforced beam

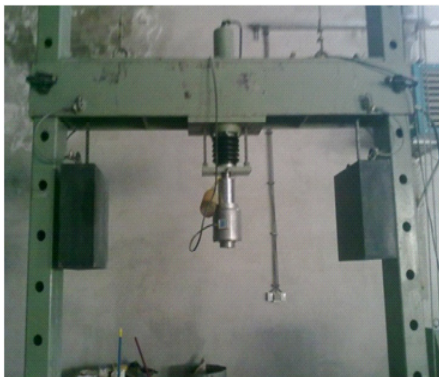
**Fig. 4: Test apparatus**

The test is performed by using a fixed jack with a nominal capacity of 160 kN and the ability to measure the force - displacement (see Figure 4).

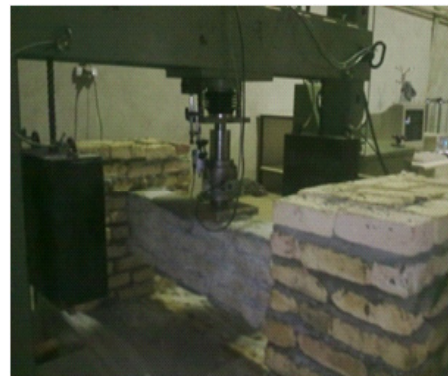
**Fig. 5: The location and orientation of loading on the samples**

In both tests, a rigid plate with dimensions of 215 \* 200 \* 22 mm is used for relatively monotonic distribution of concentrated load. The uniform load per unit of time is equal to the displacement of 2 mm per minute. The displacement of the center of the beam is measured. Figure 5 shows the location and orientation of the rigid plate and the loading.

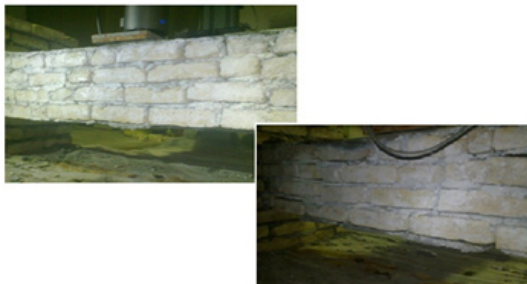
**Fig. 6 : The failure of mortar and bricks at the lowest sample parts**

In both cases, the reactions begin with failure and detachment of first brick row (see Figure 6). In accordance with the results of other tests on masonry walls by the researchers<sup>5,6</sup>, diagonal cracks originate in the bottom of the beam and in the both ends (see Figure 7). By continuing to load the non-reinforced beam, it is seen several failures due to the development of cracks in the mortar, bricks, and

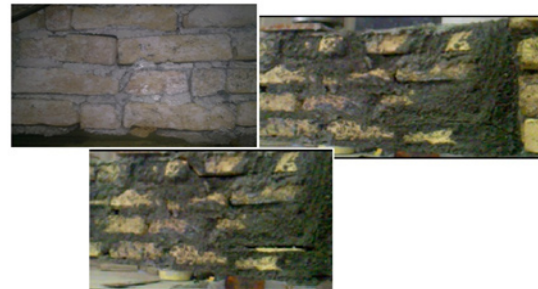
**Fig. 7: Bigger cracks initially originate from the lower two sample ends**

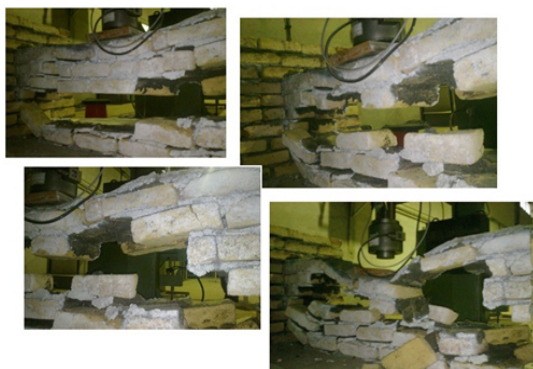
**Fig. 8: The diagonal cracking development until the complete failure of non-reinforced beam**

also the joints between the lower and middle parts of the beam (see Figure 8). Loading is continued until a complete failure of the beam.

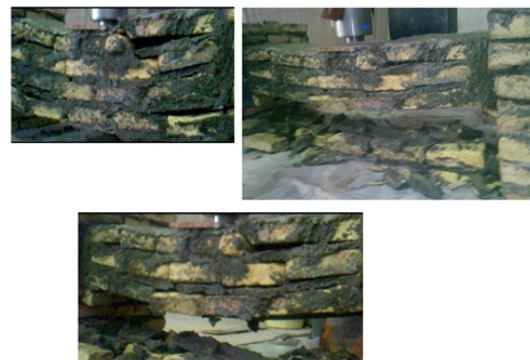
**Fig. 9: Cracking and detachment of material in the reinforced beam**

The test on the reinforced beams is the same as beam without reinforcement, with the difference that in the test, the loading is performed in 3 steps due to the device limitations in recording the displacements of more than 55 mm. Note that the reinforcement percentage is equal to 0.0073 of the beam cross section. In the first step of loading, the failure of mortar's and bricks' joints begin at the bottom row (see Figures 7-8) much less rapidly than of the non-reinforced beam. The Figure 9 shows the detachment of material and development of cracks. In the last loading, all the material of beam are failed.

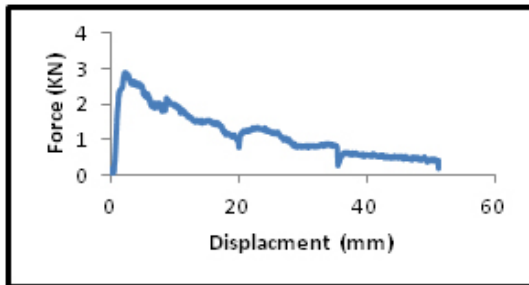
**Diagram 1: Force -displacement curve of the non-reinforced beam**

Diagram 1 illustrates the test results of non-reinforced beam. The maximum force and displacement are presented in the Table 4. The failures which are also recorded in the descending

part of the curve indicate great ones. Complete failure of the beam is occurred at the displacement of 51.3 mm.

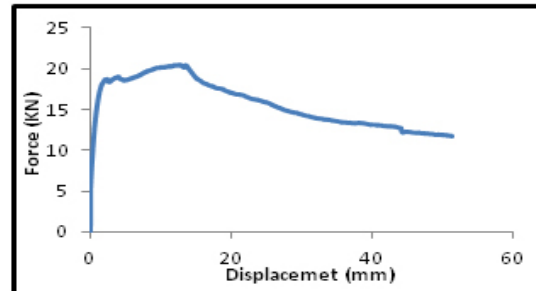
**Diagram 2: Force-displacement curve of reinforced brick beam with longitudinal rebar**

Diagram 2 corresponds to the force - displacement curve of the reinforced brick beam, while Diagram 3 shows the force - displacement curve of reinforced brick beam with loading-unloading in three steps. The data is given in Table 5.

In the Diagram 2, there is seen a failure close to the force of 20 KN, while it is obvious a simultaneously increasing strength of all three longitudinal rebar rows.

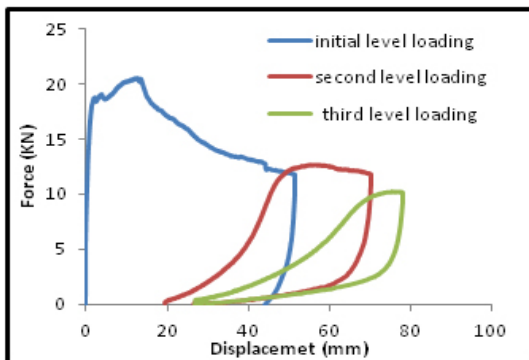
**Diagram 3: The displacement of loading-unloading in three steps on the reinforced beam with longitudinal rebar**

After three steps of loading-unloading, the deformation of masonry components is equal to 77.96 until the complete failure and detachment.

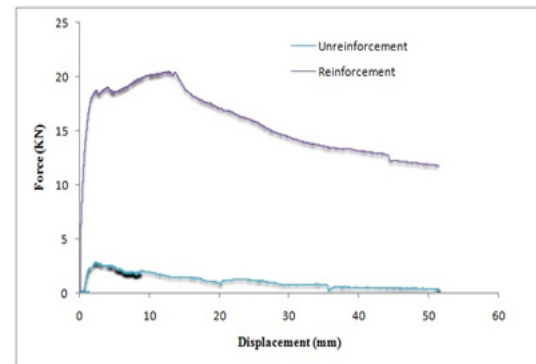
**Diagram 4: Load – displacement of brick beam (reinforced and unreinforced)**

As mentioned in previous paragraphs, the main purpose of current study is investigating difference of cutting performance in beams which are and are not reinforced with longitudinal armatures. Accordingly, best mixtures were selected and model samples were prepared to test impacts of pressure on brick units in combination with different mortars and also in order to analyze results of other studies. The results indicate considerable difference in forming and loading capacity of the reinforced beam comparing to unreinforced ones (diagram no. 4). The results are summarized in table 6.

According to table 6, the beam’s loading capacity was increased from 2.87 KN to 20.54 KN

by reinforcing the beams which is about 7 times more than unreinforced conditions. Moreover, displacement in maximum load condition increased from 2.26 to 12.78 which is about 6 times more than primary status. It is noteworthy that final displacement of the beam was increased from 51.3 mm to 77.96 mm.
