## Environmental Impact Assessment of Anthropogenic Activities and Conceptual Restoration Strategy for Kham River in Aurangabad, India

### Abstract

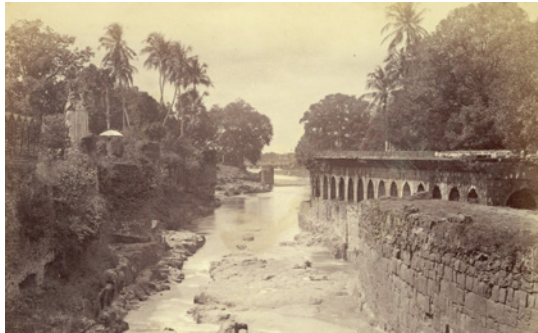
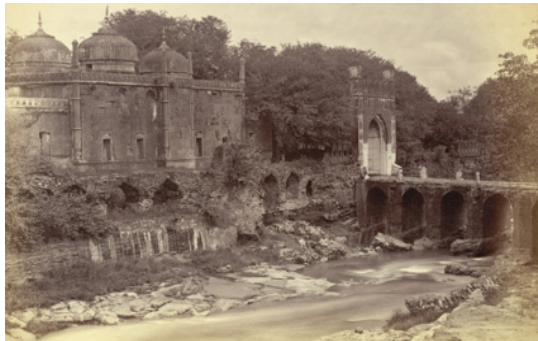
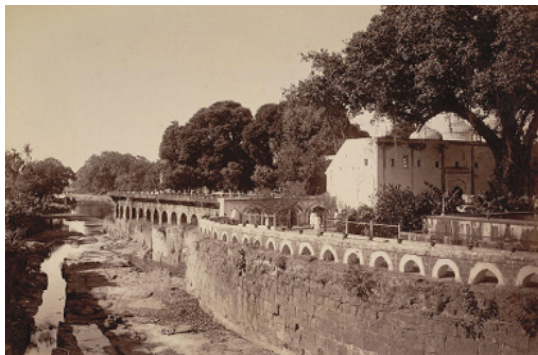
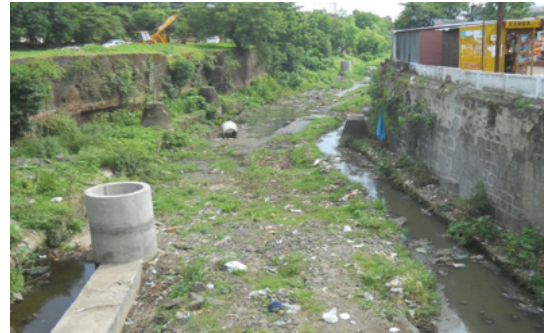
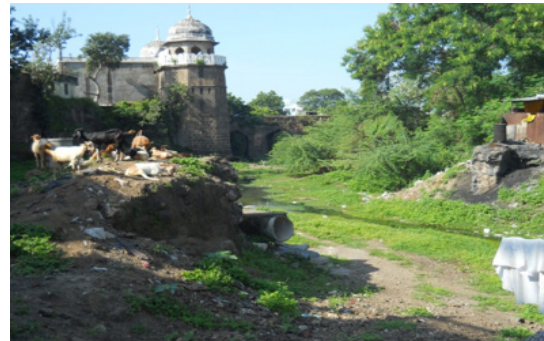
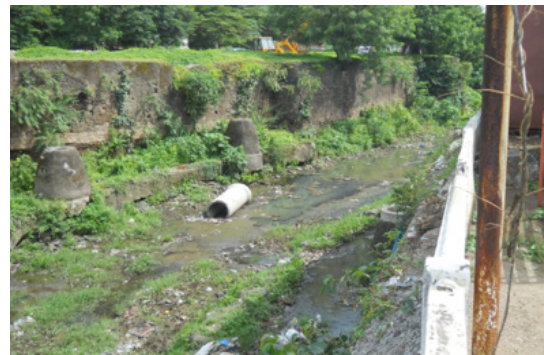
**Fig. 1: Past and Present condition of Kham River**

The present and past condition of the Kham River at various locations is shown in Figure 1. The past photographs were taken by unknown photographer in 1860s, available at Allardye Collection: Album of views and portraits in Berar and Hyderabad<sup>19</sup>.

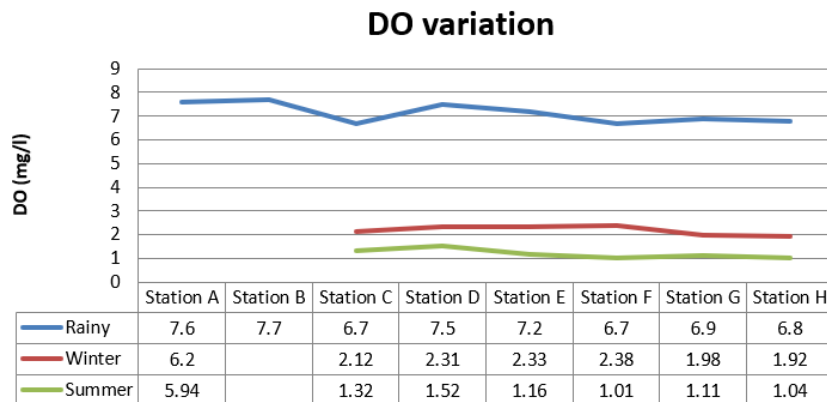
**Fig. 6: Graph showing variation in Dissolved oxygen**

biochemical oxygen demand. The obtained results are compared with the standards prescribed by World health organization (WHO)<sup>27</sup> and central pollution control board (CPCB)<sup>24</sup> as stated in Table 5. The results obtained for rainy, winter and summer season are stated respectively in Table 6, 7 and 8. Similarly the graphical variation of Dissolve oxygen (DO) and Biochemical oxygen demand (BOD) is shown in Figure 6 and 7<sup>18</sup>.

The water quality is good in the upstream reach of the river as compared to the downstream reach. The DO of the water is more in rainy season as compared to winter and summer season, this is due to dilution of the polluted water in rainy season. The DO level depletes in summer as the water in the river is only the dry weather flow. The CPCB standard is hardly achieved in summer and winter due to less DO. The BOD level in the river is less in upstream reach as compared to downstream. Similarly the BOD increases in summer as there is only the dry weather flow in the river. The BOD level as per standard of CPCB should not exceed beyond 30 mg/l, but it is only achieved in the upstream, sampling station. The pH of the water is on basic side. The TSS level is more in rainy season and less in summer and winter as sediments are carried in the river during runoff.

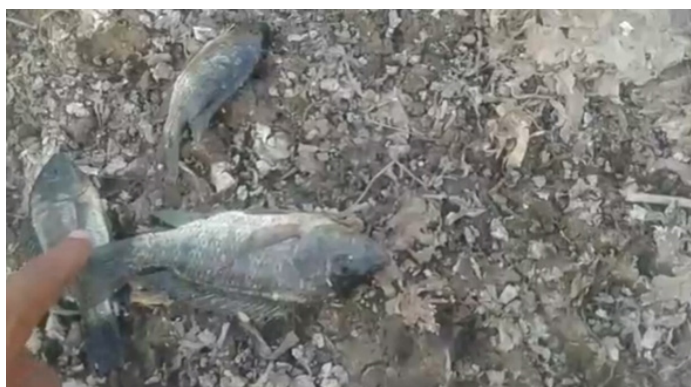
**Fig. 8: Observed fishes in upstream stretch of study area**

The surveyed species of the Aquatic plants are tabulated in Table 9 as per the classification adapted from Arber, 1920. The surveyed species of the birds are stated in Table 10. It is observed that the fishes are present in the upstream stretch of the Kham River; the observed fishes are shown in Figure 8.

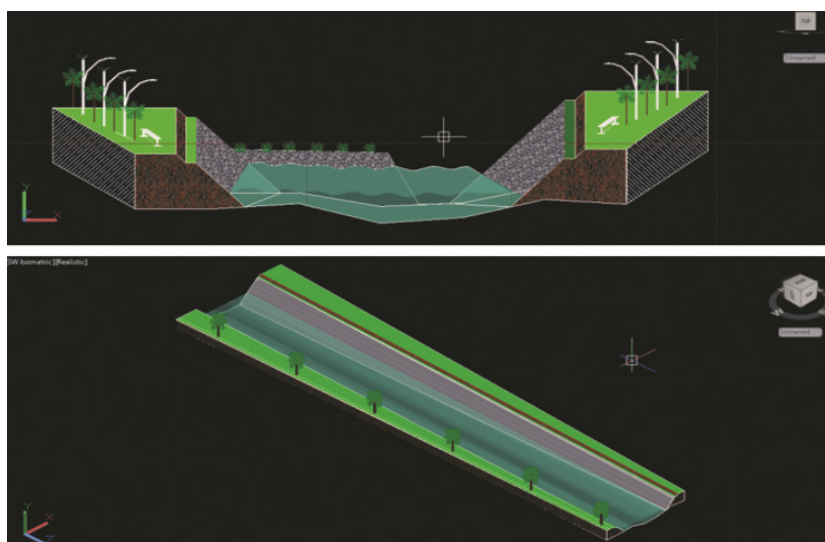
**Fig. 10: Probable three dimensional restored section**

8. Increasing the awareness among the people to protect the river from encroachment and maintaining cleanliness and hygiene along the river.
9. Probable three dimensional restored section is as shown in Figure 10

4. The portion of the river of 3 km i.e. from the Harsul Lake to Himayat baug needs special attention on strengthening the side banks of the river by constructing embankments, river deepening and widening at required locations and constructing bunds in series for water retention which can be used for recreational purpose.

5. The portion of the river of 5 Km i.e. from the Himayat baug to Chavani bridge needs special attention on river widening by removing the encroachments by taking the mean width of the river as 36.13 meters, aligning the sewer drains to both of the banks is preferable as the portion on top of it can be used as a walkway and microbial beds or green bridge system can be accompanied for enhancing the water quality.
